# Servicing the Maxon Micro-Ratio Valve

MEGTEC recommends that this procedure be completed on an annual basis. Performing this maintenance procedure may prevent or resolve temperature control or over temperature fault issues.

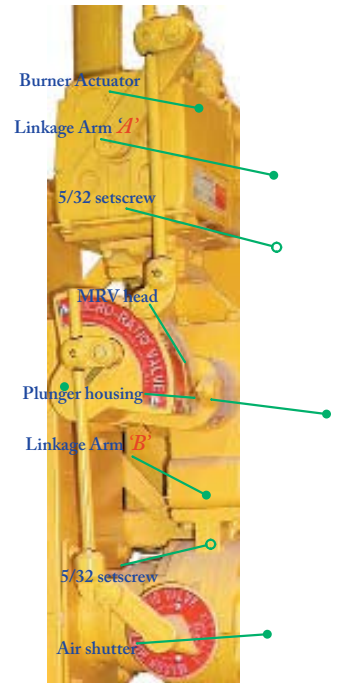
Figure 1. Micro-Ratio Valve Components

Figure 1 shows the Micro-Ratio Valve Assembly. To disassemble the valve, loosen the linkage arms at the knuckles located on the MRV and the air shutter. Note that the 5/32 setscrews may be located on the front or the backside of the knuckles. Disconnect the 'A' linkage arm at the MRV air shutter. Disconnect the 'B' linkage arm at the MRV. The 'A' linkage will remain attached to the MRV when it is removed. Proceeding with this method of disassembly will prevent the burner settings from changing when the valve is re-assembled.

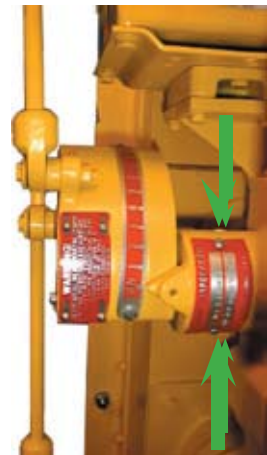
With the linkage arms disconnected, back out the 3/16 setscrews about 3/8 of an inch (See Figure 2.) Move the valve so the 'MAX' point lines up with the indicator. Using both hands, turn the valve back and forth and away from the burner until the valve separates from the plunger housing. The valve is mounted with a metal-to-metal fit and may offer some resistance.

Figure 2. The arrows indicate the location of the 3/16" setscrew

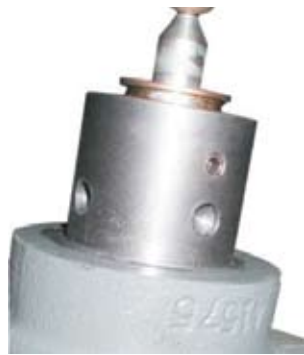
Figure 3 shows the plunger assembly being removed. To loosen the brass insert, locate the 1/8 Allen setscrew as shown in Figure 4. Back the setscrew out about 1/4 inch. Using a flat screwdriver, gently pry the brass insert free of the valve body.

Figure 4. Setscrew location that is used to allow the plunger assembly to be removed from the plunger housing.

Insert the plunger assembly fully into the valve body and make sure it seats fully. Then tighten the 1/8 setscrew that secures it in place. If the plunger assembly is not inserted properly the MRV head will not line up correctly.

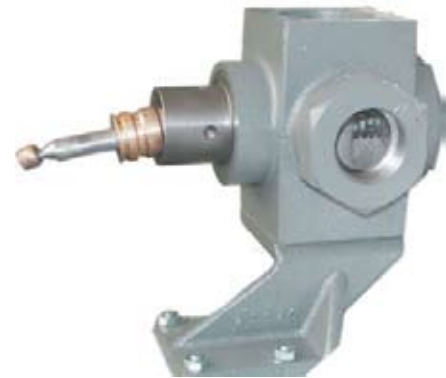
Figure 3. Plunger assembly being removed from the plunger housing. Do not pull the shaft out of the brass insert until the entire plunger assembly has been removed!

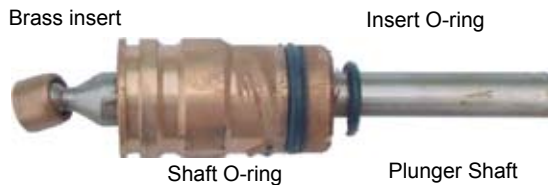
With the plunger assembly removed, remove the 'shaft O-ring' and the shaft from the brass insert (figure 5). Clean the entire assembly with WD-40 or a parts washing solution. Do not use blanket wash on the O-rings, they will dry out and come apart. Using a fine Scotch-Brite pad clean any paint or rough spots from the shaft.

Figure 3. Shows the plunger assembly after it has been removed from the plunger housing. Note: the shaft O-ring will fall into the housing if the shaft is pulled out of the brass insert before the complete assembly is removed. This O-ring is very important as it prevents gas from leaking at the MRV pivot joint.

One note of caution: Do Not pull the plunger out after the valve has been disassembled! There is an O-ring on the backside of the plunger that will fall off (See figure 5 ).

After the plunger assembly has been cleaned, lubricate the plunger assembly with good lithium grease. The shaft should be fully greased before it is inserted into the brass insert. The area around the shaft O-ring should be fully greased. The area around the O-ring on the brass insert should be lubricated generously as well.
